Assessing the importance of river bank erosion for fine sediment delivery to Bassenthwaite Lake

Thesis for M. Sc. (by research)

Durham University, Department of Geography

2007

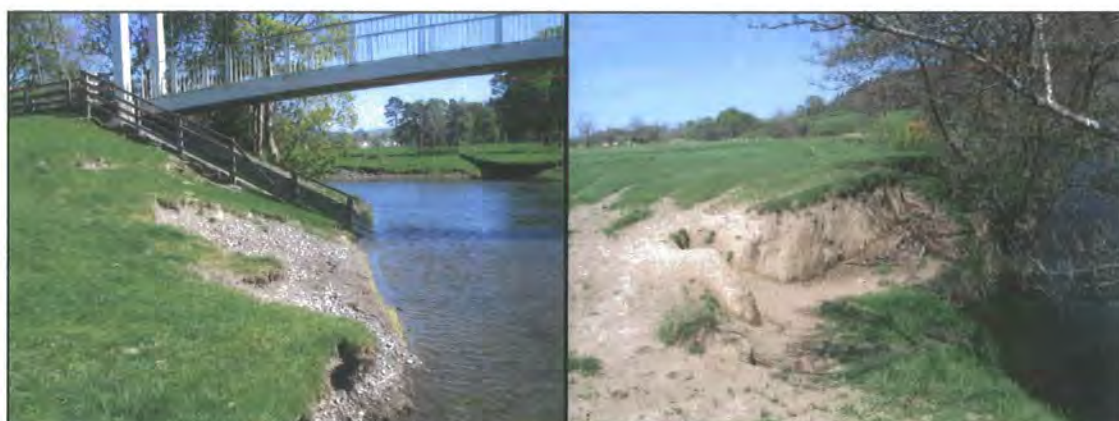
Figure 2.3: Poaching scars at Portinscale (left) and Low Stock Bridge on the River Derwent, Cumbria (right) showing trampled, disturbed fine sediment in areas of grazing.

and Radford 1994). Such scars frequently form on river banks where agricultural land borders the channel (Figure 2.3), and loosened material can be easily entrained by high flows. In some upland grazing areas, including the northern slopes of Skiddaw (Figure 1.3), the installation of networks of drainage channels known as grips has taken place (Figure 2.4) in order to increase the area of grazing land. The erosion of such grips has the potential to contribute fine sediment to the lowland catchment, with additional increases in peak flows following the installation of upland drainage networks (e.g. Conway and Millar 1960, Knighton 1973).

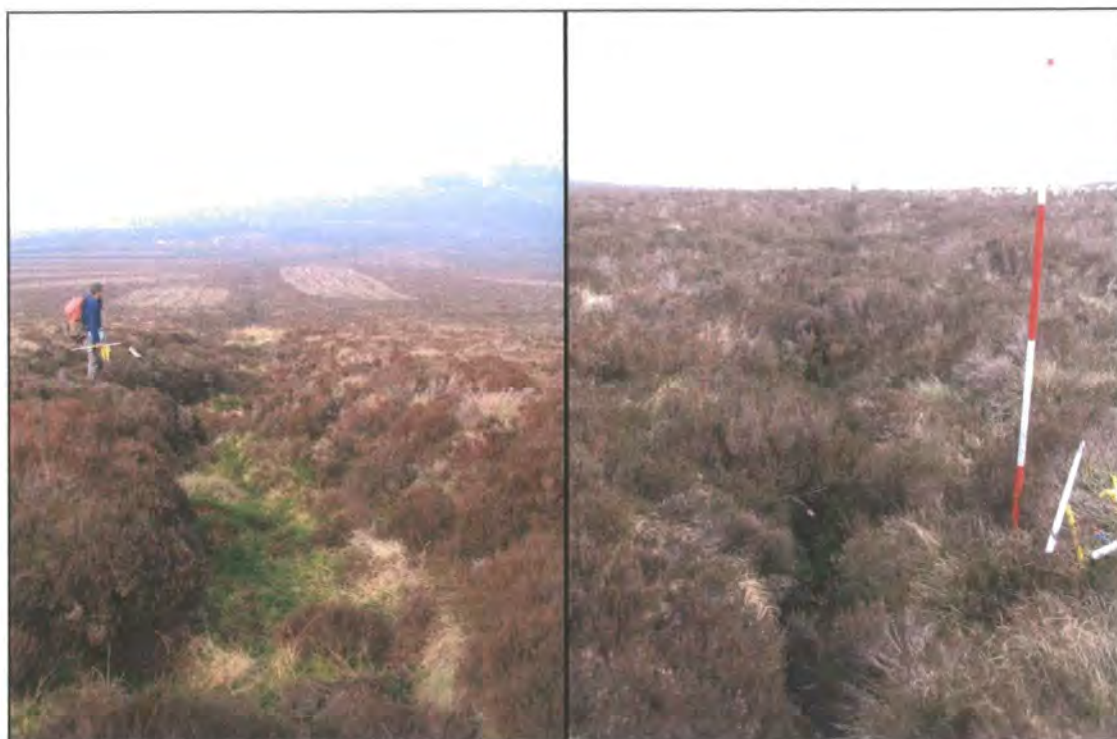
Figure 2.4: Grips at Candleseaves Bog (NY 277 304) near Skiddaw House, showing parts of the network of narrow and deep (maximum depth c. 1m) drainage channels cut into the peat bogs on heather moorland close to the Derwent/Eden watershed.

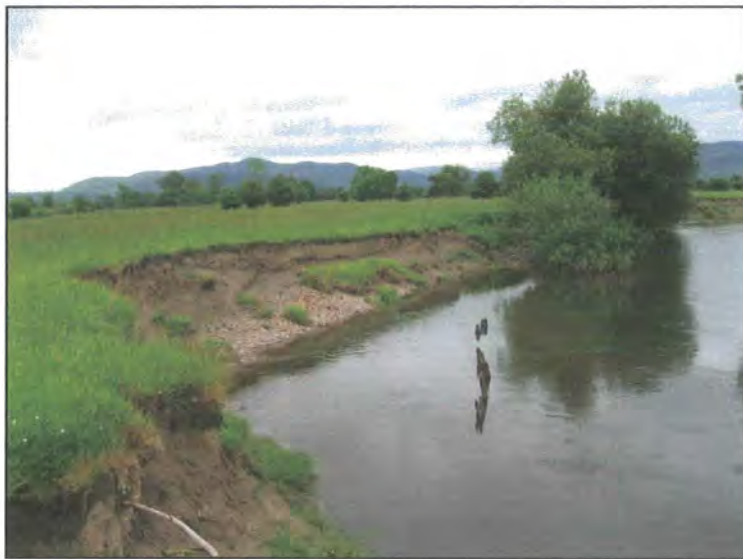
Figure 2.6: A line of ruinous wooden revetments in the River Derwent's channel at erosion study bank 2 near Low Stock Bridge (NY 237 266), showing obvious retreat and erosion of the bank back from the revetments.

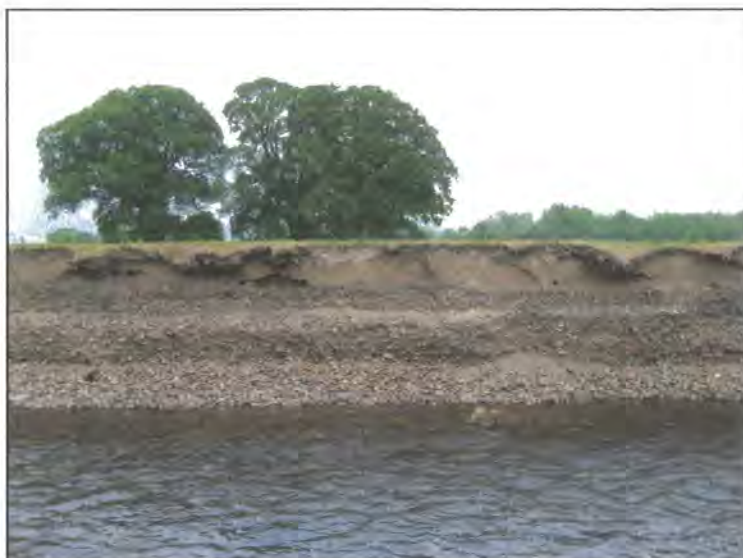
Figure 2.14: A well-developed, eroding composite river bank near Portinscale Bridge (height c. 2.5 m). Note the cohesive upper layer of fine-grained sandy material overlaying a non-cohesive lower layer of coarse pebbles and gravel. The turf slippage and slight overhang development at the bank top, and the steepened profile of the lower bank suggest recent active erosion of this bank.

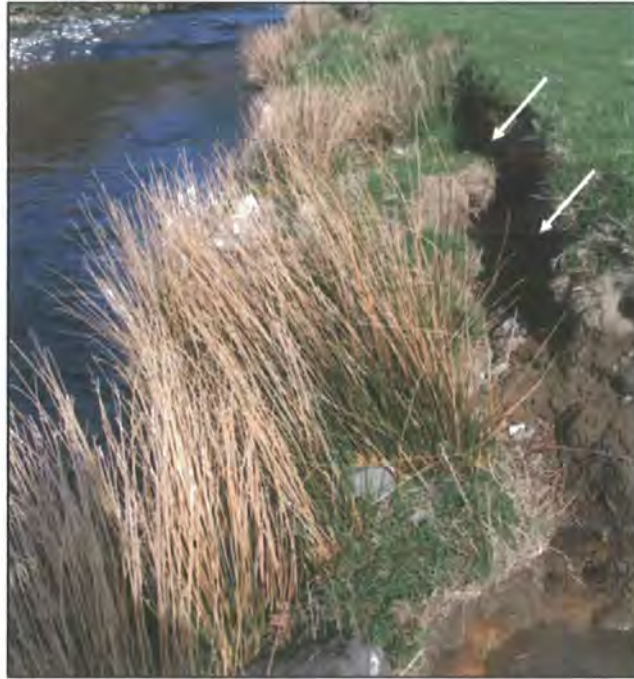
Figure 2.16: Shallow slip failure on the river bank of St. John's Beck, St. John's-in-the-Vale, Cumbria. The failed block has not been further eroded and it remains well vegetated. An obvious tension crack (indicated by the white arrows) is situated between the failed block and the retreated bank face.

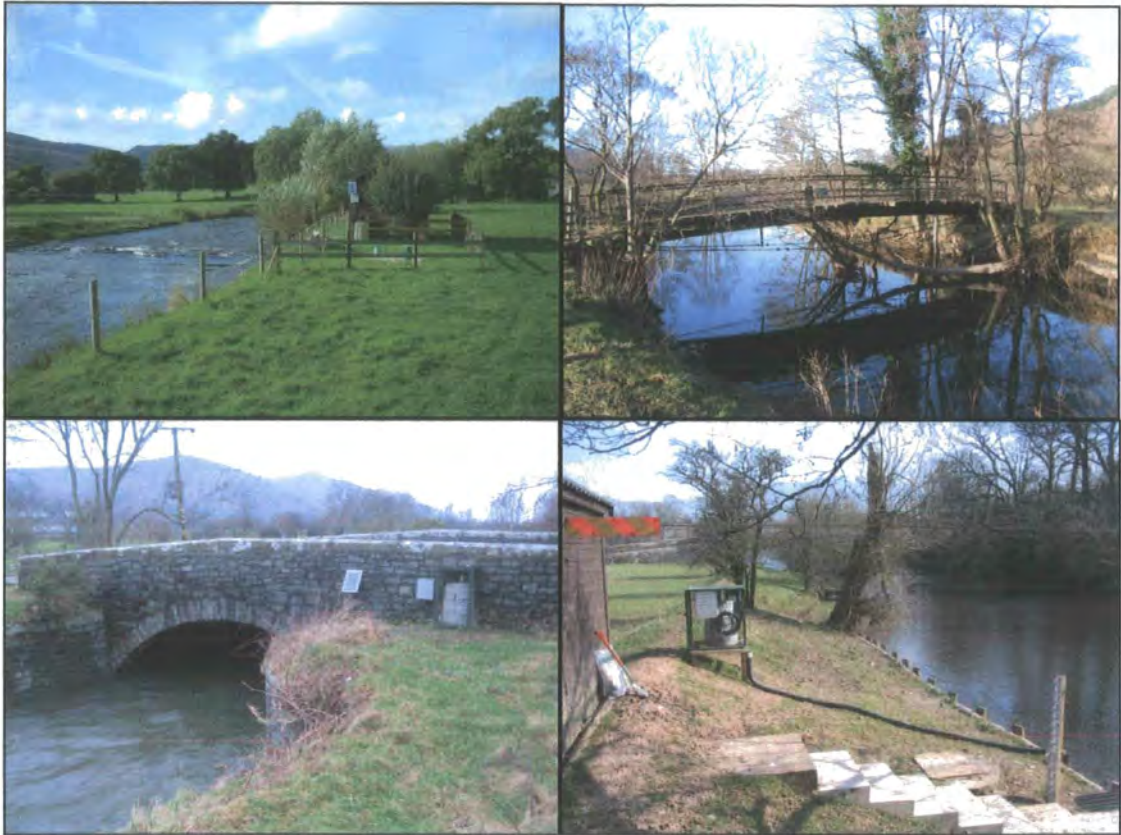
Figure 3.3: Monitoring stations used to collect turbidity data and river water samples:

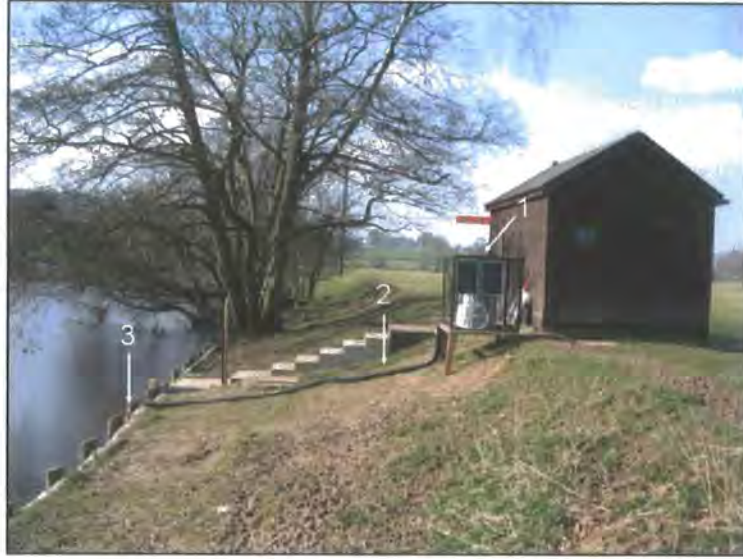
Figure 3.4: Field monitoring station at Ouse Bridge. The elevated cage (1) contains the automatic water sampler and datalogger (not visible). The black pipe (2) leading down the bank contains the turbidity probe wire, water sampler tube, sampler float switch and pressure transducer. The turbidity probe and water sampler tube are attached to the bank face at the stilling well (3). The two solar panels on the cage supply power to the datalogger battery. The hut close to the cage is an Environment Agency river level and flow gauging site, which collects river stage and discharge data.

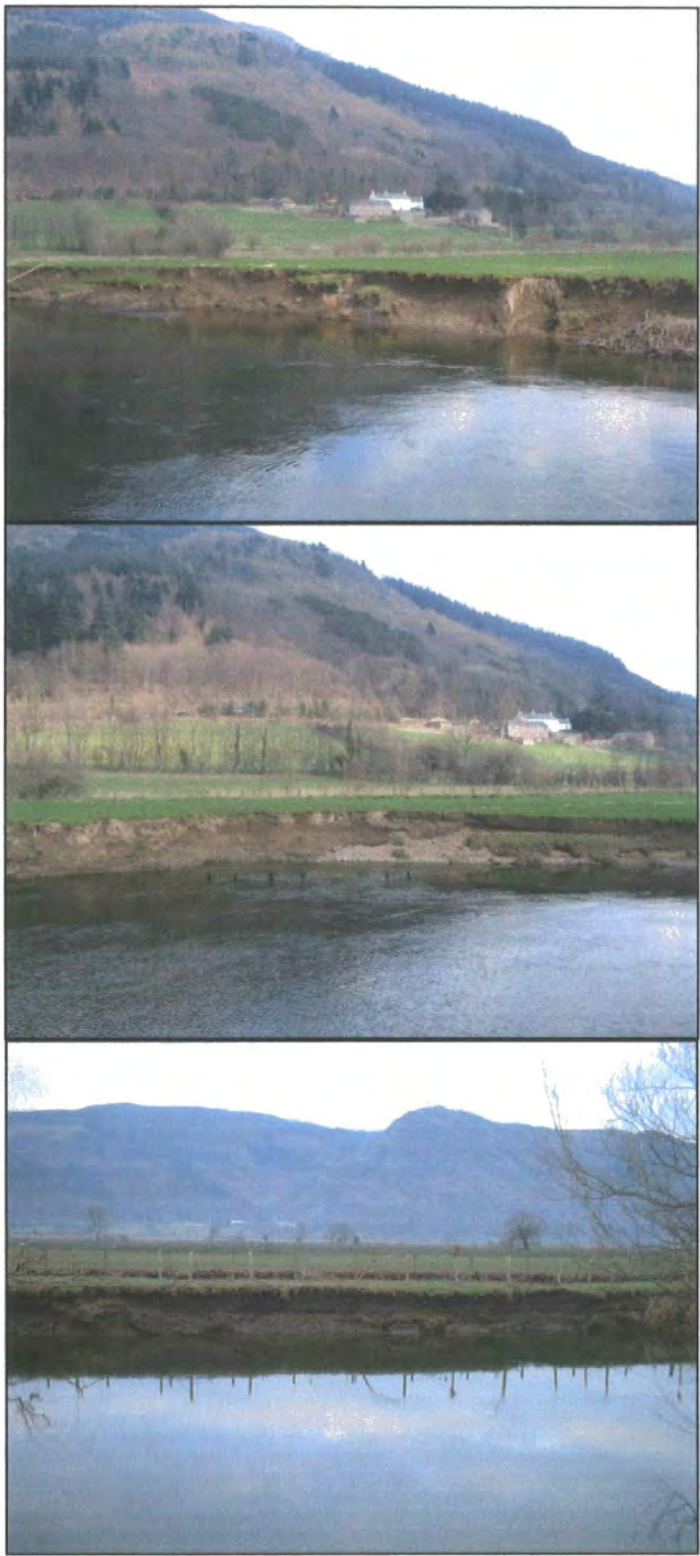
Figure 3.7: The three river bank sections analysed in the river bank erosion study in this project, showing bank 1 (top), bank 2 (middle) and bank 3 (bottom).

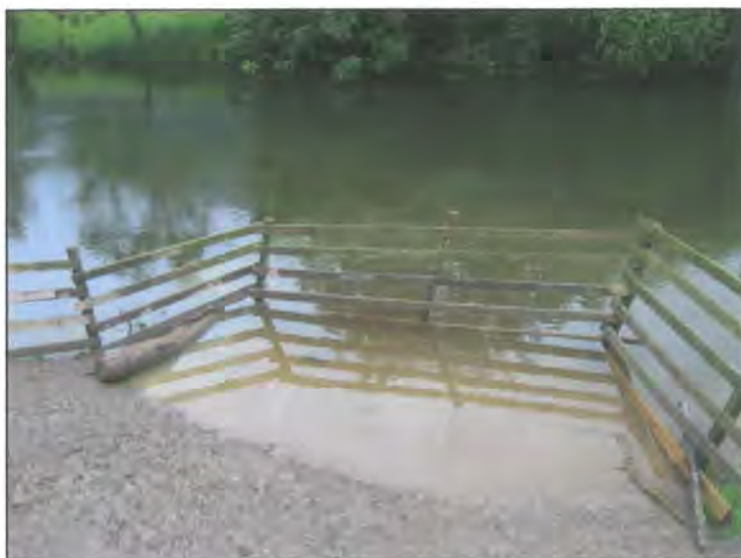
Figure 4.11: Suspended sediment addition to the River Derwent from an area of bare soil in the large poaching scar c. 150 m upstream of Low Stock Bridge (NY 244 257) following heavy rain, 22nd June 2007.

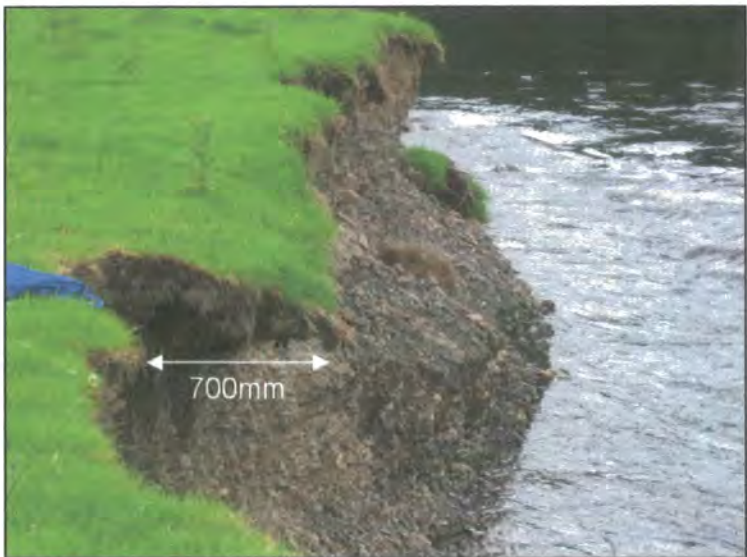
Figure 4.22: Considerable undercutting (indicated) at bank 3 following a rise in river levels, also note the oversteepened profile of the lower bank.

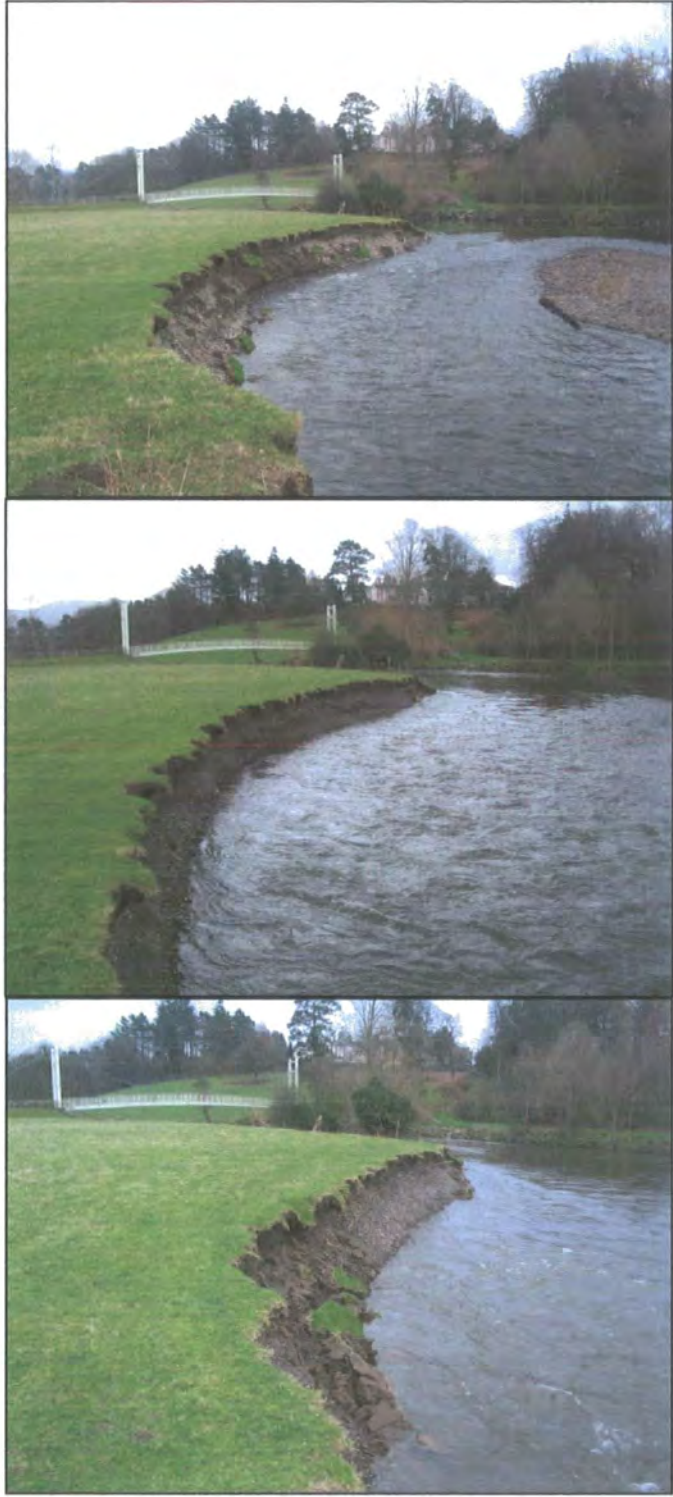
Figure 4.23: Block failure events and material removal from bank 3 near Portinscale suspension footbridge (looking upstream). Photograph dates: Top - 19th February 2007, middle – 5th March 2007, bottom – 11th March 2007.

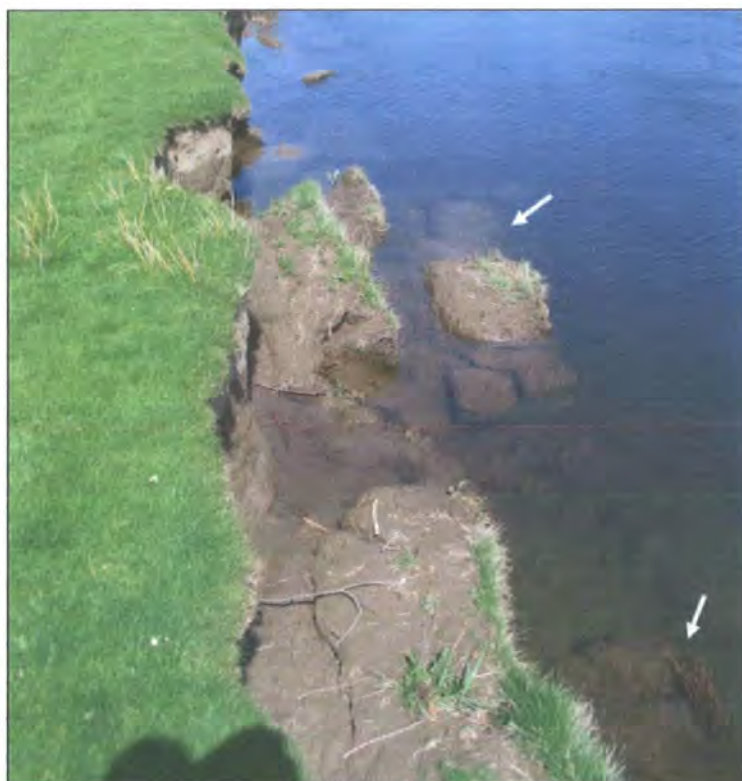
Figure 4.28: Unvegetated, intact blocks (indicated by white arrows) lying in the river channel below more recent failures at bank 6 (flow direction: away from photograph).

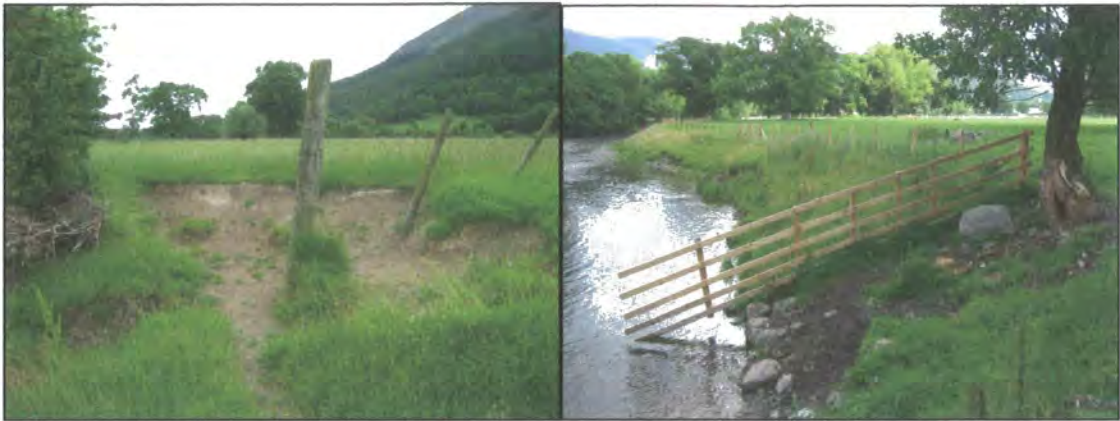
Figure 4.33: Examples of poaching scars formed near to fences in areas of channelled grazing: upstream of Low Stock Bridge (NY 237 264) (left) and near Portinscale (NY 253 237) (right).

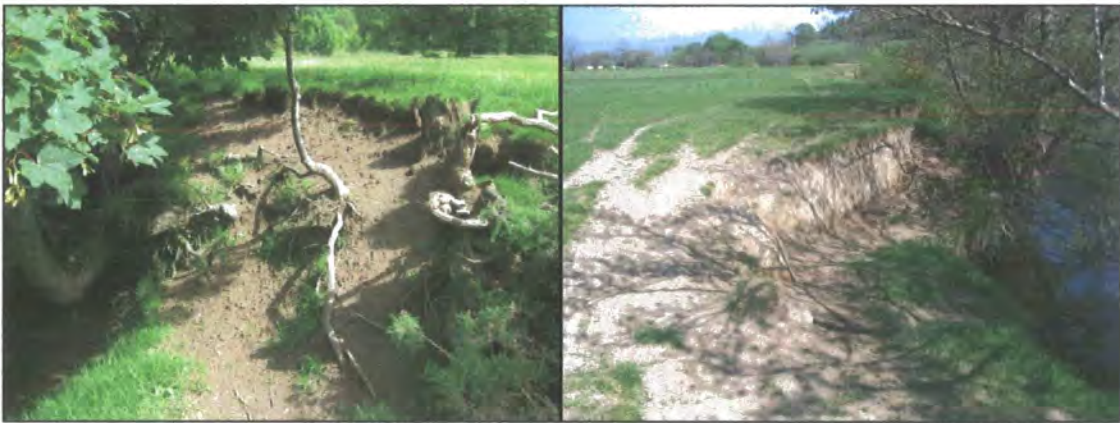
Figure 4.34: Examples of poaching scars that have formed in sheltered areas of river bank: under trees near Portinscale (NY 251 240) (left), and below a steep bank face downstream of Low Stock Bridge (NY 236 268) (right).

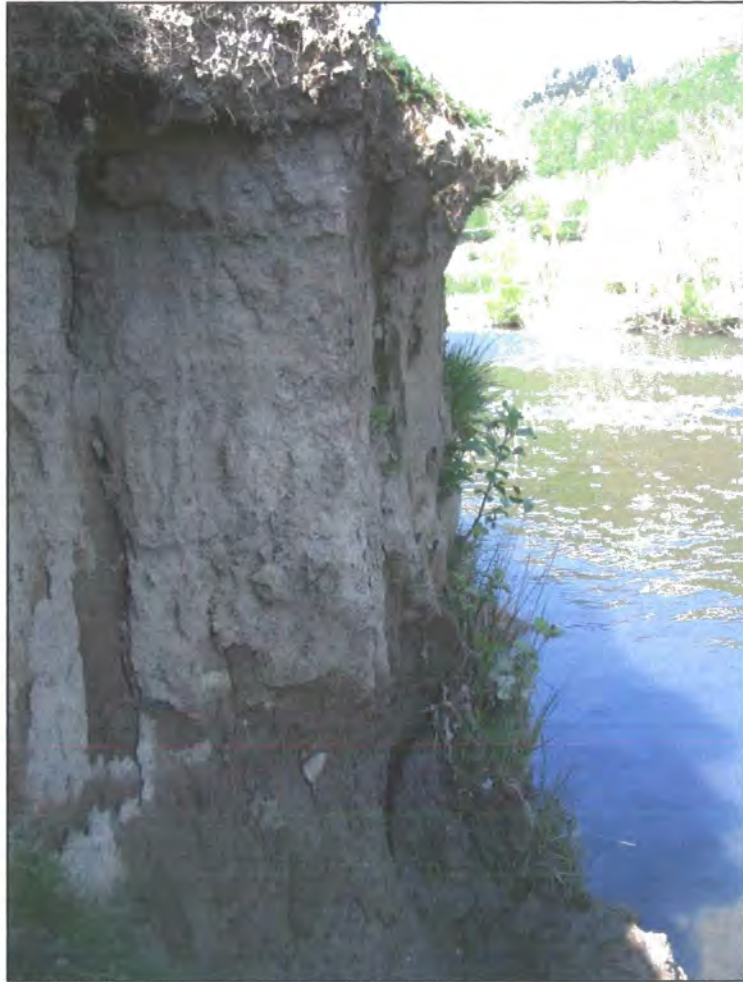
Figure 4.36: Desiccated river bank face downstream of Low Stock Bridge at NY 235 269, showing the moisture contrast between the (dry) upper and lower bank.
